CITY OF SASKATOON

Asbestos-Containing Building Materials Assessment Report - Supernatant Pump Station (North 40 Sludge)

Report Number: 1667963

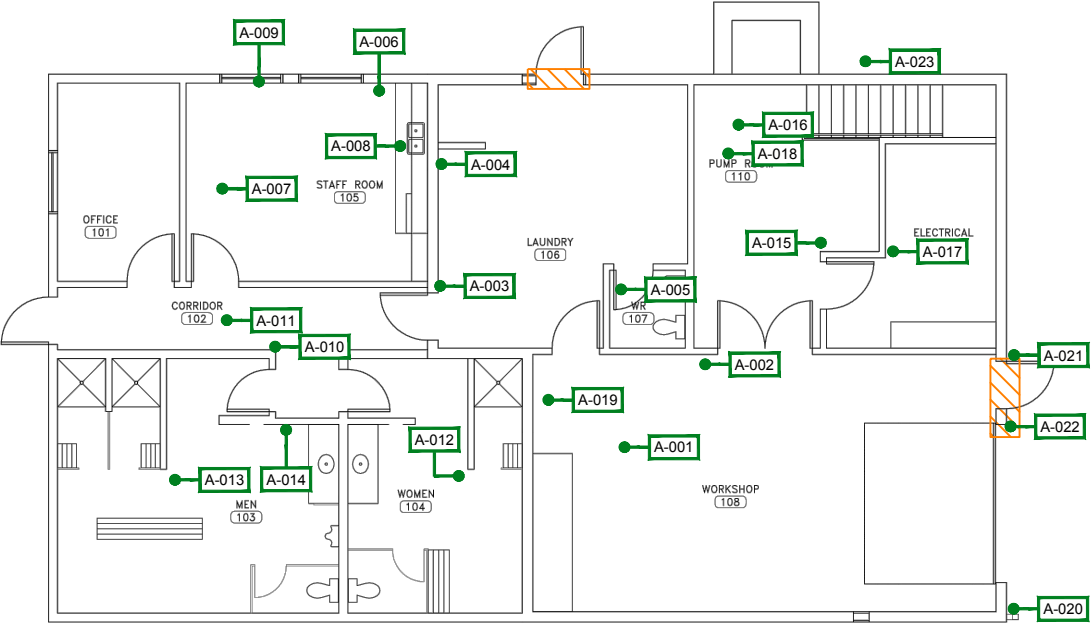
Floor Plans

One (1) sample of grey caulking was collected during the assessment. The sample collected was found to contain 0.25% Chrysotile asbestos. Asbestos-containing grey caulking (see Photograph 1 in Appendix B) was observed in the following locations:

If scheduled for impact, asbestos-containing exterior grey caulking should be abated following low-risk abatement work procedures as outlined in the *Saskatchewan Asbestos Abatement Manual* (2017). Alternatively, as the caulking was observed in good condition, and with a priority rating of 5 (please see the room by room spreadsheet provided in Appendix C for a description of the priority ratings), the caulking can be managed in place if not scheduled for impact.
