## TECHNICAL MEMORANDUM

**Project No.** 20138294

### NUTANA SLOPE INSTABILITY UPDATE – MAY 2020

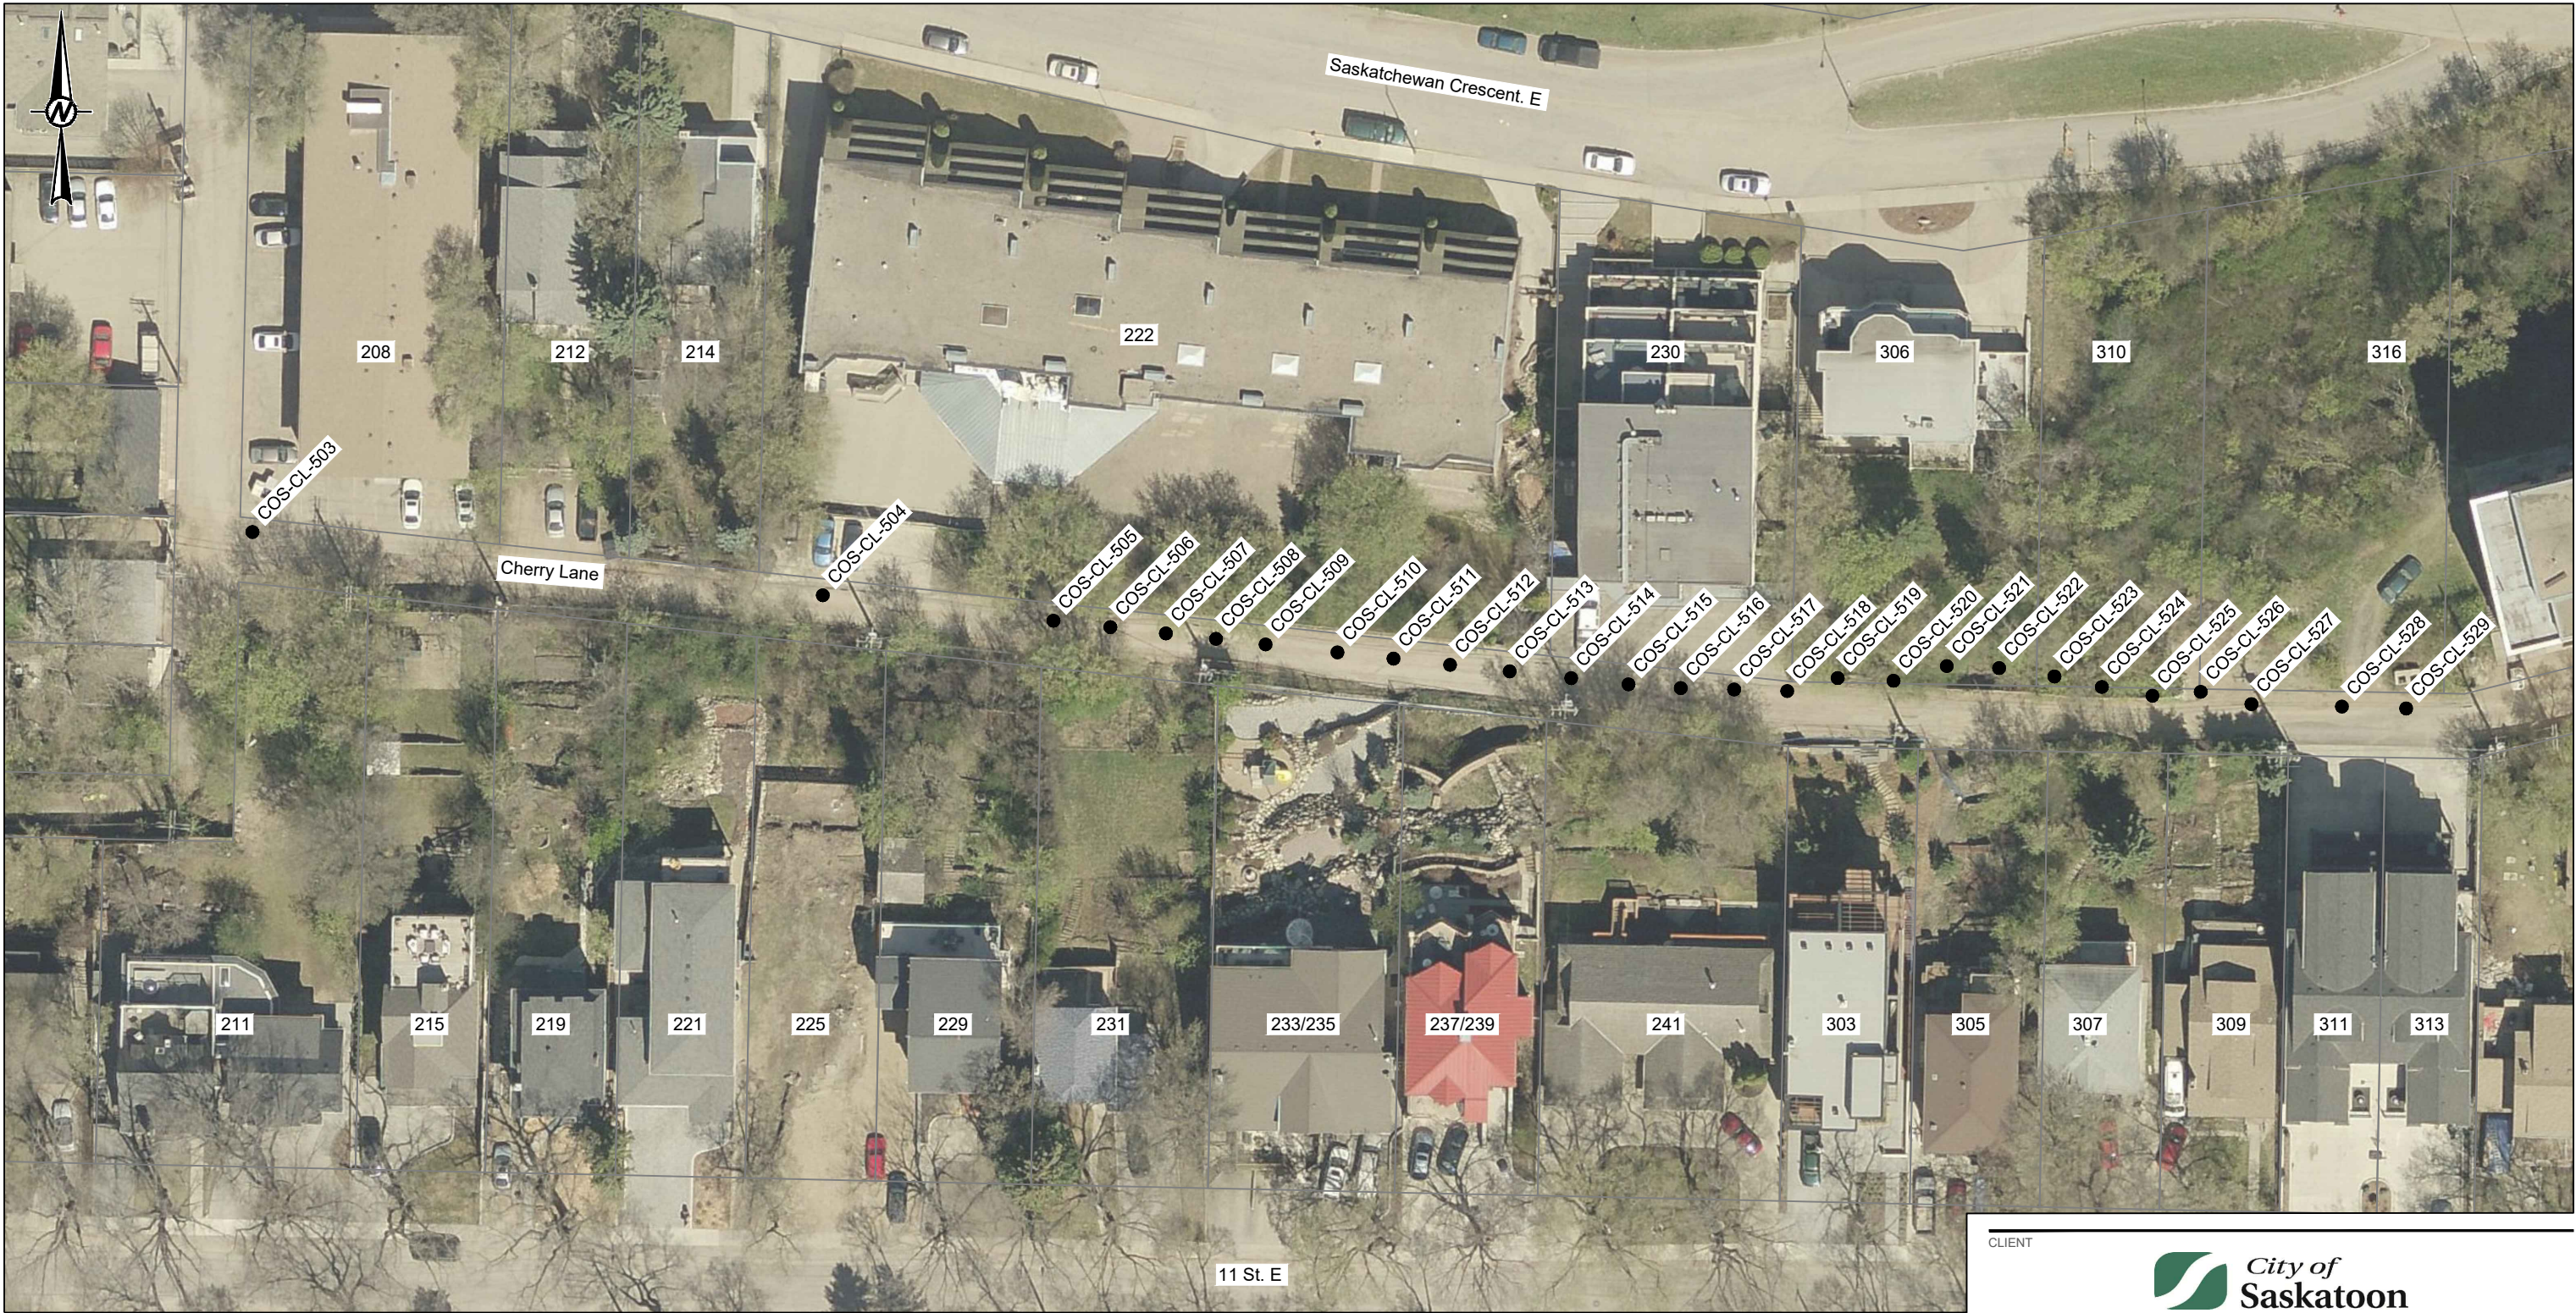
| TITLE | | | | INSTRUMENTATION PLAN No. 1 | |

This memorandum presents monitoring data for the slope failures (referred to as the west slide and east slide) at the Nutana Slope Instability site. Locations of survey pins are shown in Figure 1. Locations of slope inclinometers, piezometers, settlement points, crack meters, and tilt plates are shown in Figure 2. Locations of the Saskatoon Light & Power (SL&P) tilt plates and survey pins installed on power poles are shown in Figure 3.
