Mendel Site Safety Audit Final Report

June 27, 2011 | Community Services Department, Planning & Development Branch

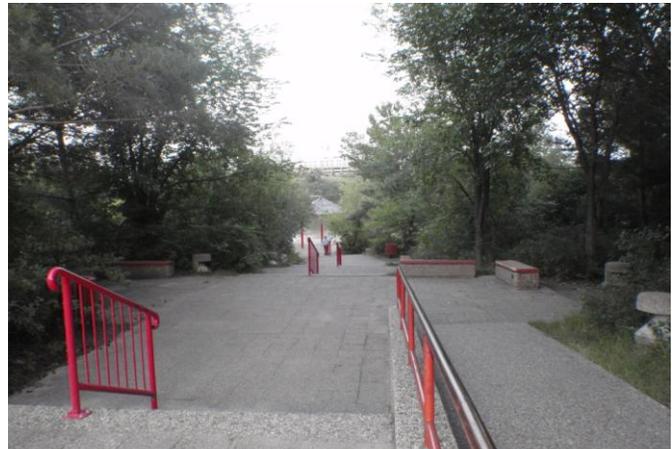
There are few activities at the Mendel Site during the late evening hours and in the fall/winter months. The site, as a result, is largely vacant during certain times of the day. Introducing new activities into the area would help to engage Saskatoon citizens and visitors and attract them to the area. These festivals or venues could be city operated or leased to the private sector.

Much of the Mendel Site is underutilized due to a lack of programming and site activities.

Finding:	There are a limited number of activities at the Mendel Site during the late evening hours and fall/winter months.
Recommendation:	That the Leisure Services Branch, Community Services Department review the feasibility of increasing opportunities to expand temporary and/or permanent community or private programming and activities within the Mendel Site.
Justification:	Encouraging activities on site supports a strong neighbourhood and community culture. Introducing new activities or venues into the area may encourage people to use the park at different times of the day, increasing connectivity as well as natural surveillance.
