SUBJECT: Bulk Sample Analysis Report

File: B67BLJ06 – Lift Station

BULK SAMPLE ANALYSIS REPORT**PROJECT NO. B67.13****CLIENT: City of Saskatoon****Water & Wastewater Treatment Branch, Saskatoon, SK.****Contact: Jonathan Laforge****Location: Waste Water Lift Stations**

ASBESTOS CONTAINING MATERIAL FLOORPLAN – 14th Street Lift Station

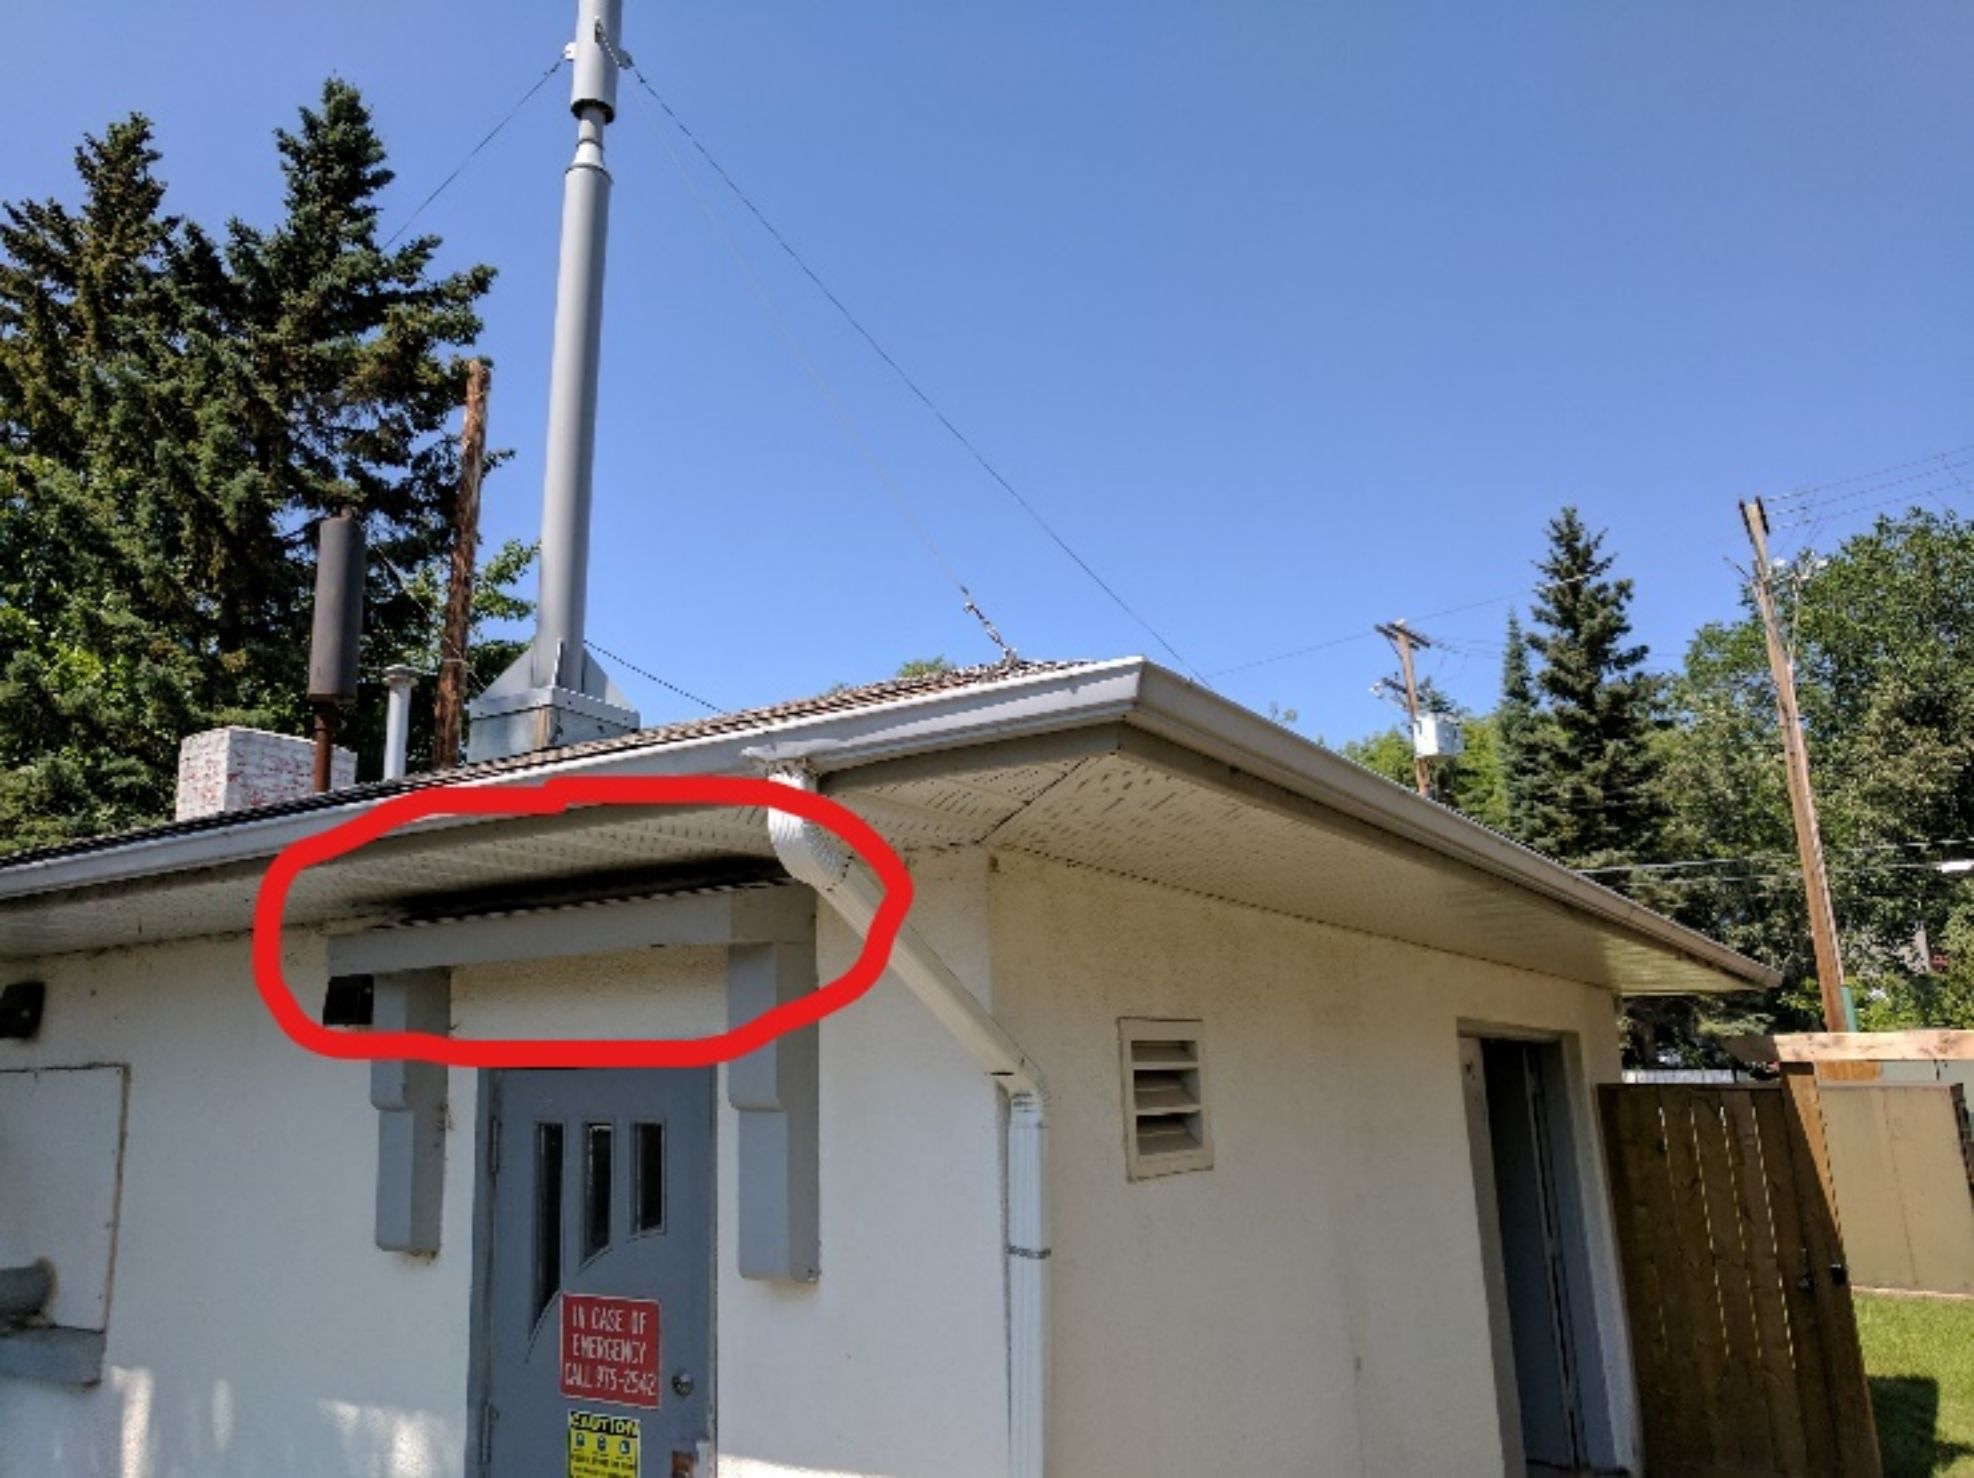
Transite Pipe used for Ventilation Piping – 40% Chrysotile, Tested Jan 9th 2013

DO NOT CUT/GRIND OR OTHERWISE DISTURB – ASBESTOS DUST IS KNOWN TO CAUSE LUNG CANCER
