SUBJECT: Bulk Sample Analysis Report

File: B67BLJ06 – Lift Station

BULK SAMPLE ANALYSIS REPORT**PROJECT NO. B67.13****CLIENT: City of Saskatoon****Water & Wastewater Treatment Branch, Saskatoon, SK.****Contact: Jonathan Laforge****Location: Waste Water Lift Stations**

ASBESTOS CONTAINING MATERIAL FLOORPLAN – 14th Street Lift Station

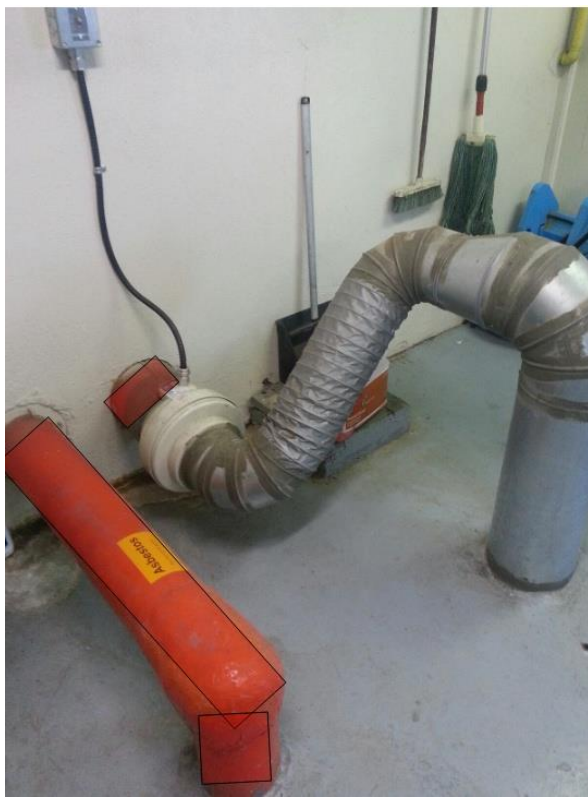
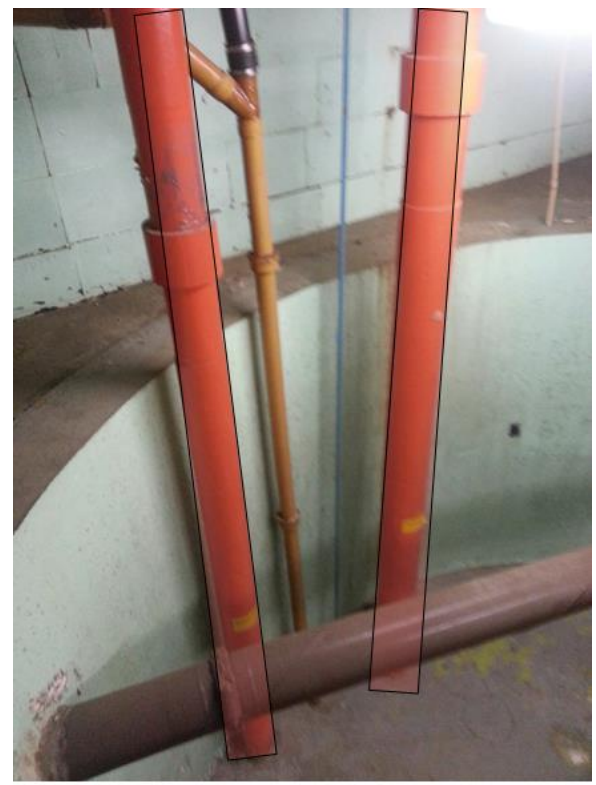
Transite Pipe used for Ventilation Piping – 40% Chrysotile, Tested Jan 9th 2013

DO NOT CUT/GRIND OR OTHERWISE DISTURB – ASBESTOS DUST IS KNOWN TO CAUSE LUNG CANCER

Asbestos Containing
