SUBJECT: Little Chief Station - Asbestos Registry Report

BULK SAMPLE ANALYSIS REPORT

Location: Little Chief Station - 344 20th Street West, Saskatoon, SK.

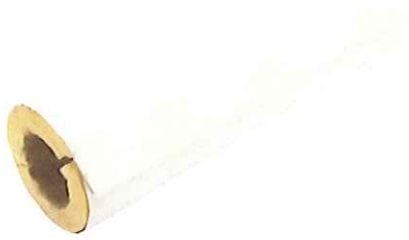
#2) Pipeline Insulation

NO.	DATE	SAMPLE INFORMATION	ASBESTOS	%	ANALYST
B1	8-May-13	Basement Mechanical Room - Paper wrap on wall in upper northeast corner	None detected		WB
B2	8-May-13	Basement Mechanical Room - Lineal pipeline insulation	None detected		WB
B3	8-May-13	102 - Gray vinyl sheet flooring	None detected		WB
