## SUBJECT: Diefenbaker Park Workshop- Asbestos Registry Report

**BULK SAMPLE ANALYSIS REPORT**

Location: Diefenbaker Park Workshop - 2610 St. Henry Avenue, Saskatoon, SK.

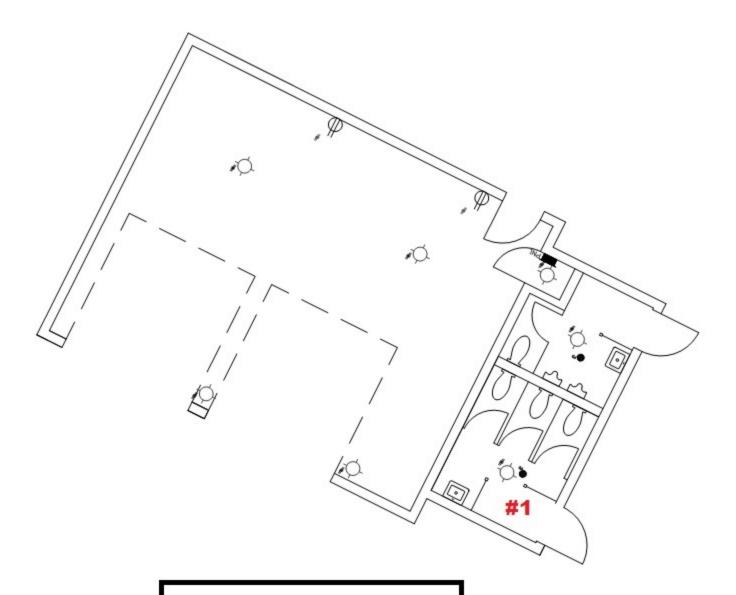
oComico en	TO	o-Cordo en	Nan-Critico	
N.T.S.		04/05/09		
SHEET NAME				
	Floor Plan			
774	L L			
Die	, fenb	aker	Pk

#\_ - Sample # Location
